Saskatchewan  
Watershed  
Authority

# Health of Riparian Areas in Southern Saskatchewan

# FACT sheet

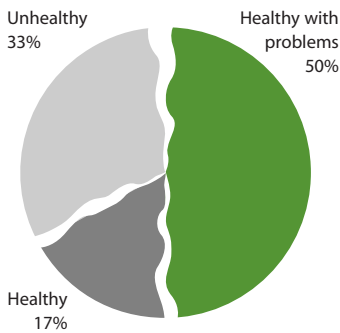
Healthy lotic riparian areas in Saskatchewan

The Saskatchewan Watershed Authority conducted assessments of approximately 830 riparian areas across southern Saskatchewan from 1996–2002. Eighty percent of these riparian areas were less than healthy.

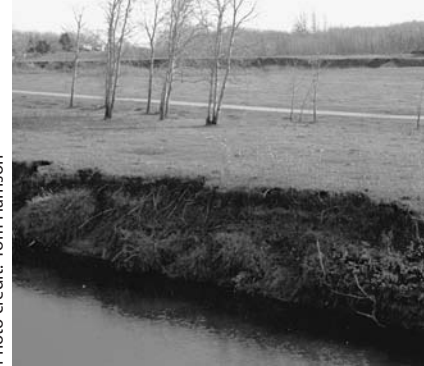
**Disturbance species are unable to prevent soil and bank loss.**

Herbaceous (non-woody) vegetation along riparian areas is also very important. Typical riparian plants such sedges and rushes can become replaced with less desirable plants called disturbance species. Disturbance species generally have shallow root systems and cannot function to prevent soil and bank loss. Seventy five percent of riparian areas had disturbance species such as Kentucky blue grass, smooth brome and sow thistle. Also of concern are many noxious weeds which tend to invade and take over riparian areas. These invasive species such as Canada thistle or leafy spurge were found on 54 percent of sites.

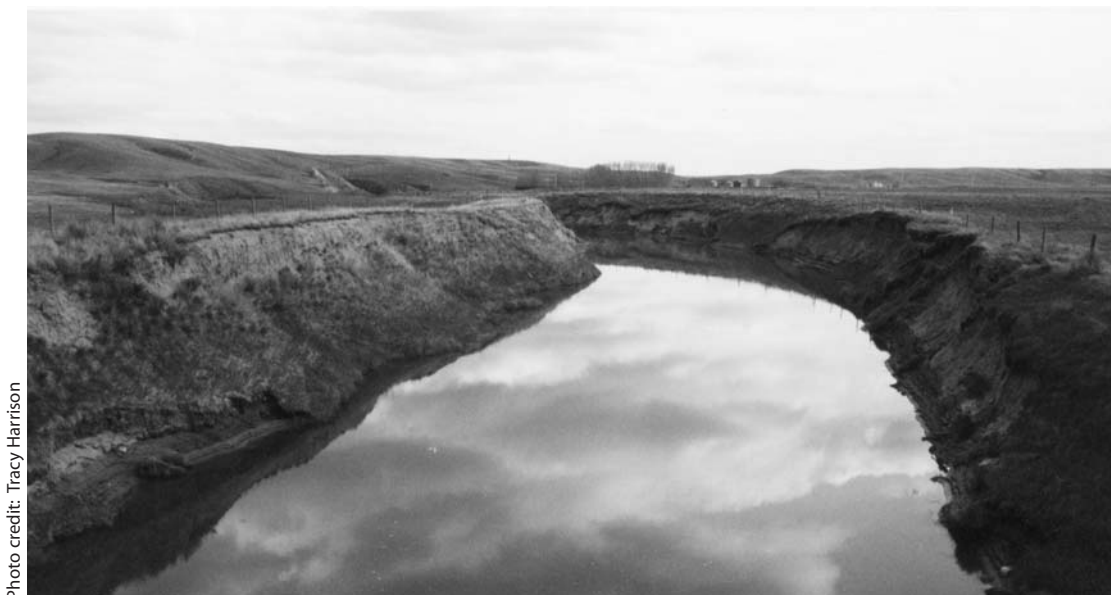
*Incised rivers are unable to reach their floodplain.*

A healthy riparian area is one which can perform the essential functions of flooding, slowing of water and ground water recharge. When a system has down cut and has a reduced ability to flood out of its banks the creek is said to be incised. Seventy four percent of streams and rivers had some degree of incisement. Water management, bank instability and channelization can cause this problem. Another important indicator of a healthy riparian area is the balance between erosion and deposition. Creeks and rivers naturally cut on the outside edge of curves and deposit on the inside of curves. If a greater proportion of the creeks are laterally cutting, excess sediment is being added to the system resulting in a decrease in water quality. Seventy percent of streams showed excess lateral cutting.
